# ENGINE DIAGNOSTICS PROGRAM CF6-50 ENGINE PERFORMANCE DETERIORATION

Ray H. Wulf

General Electric Company  
Aircraft Engine Business Group  
Evendale, Ohio 45215

November 1980

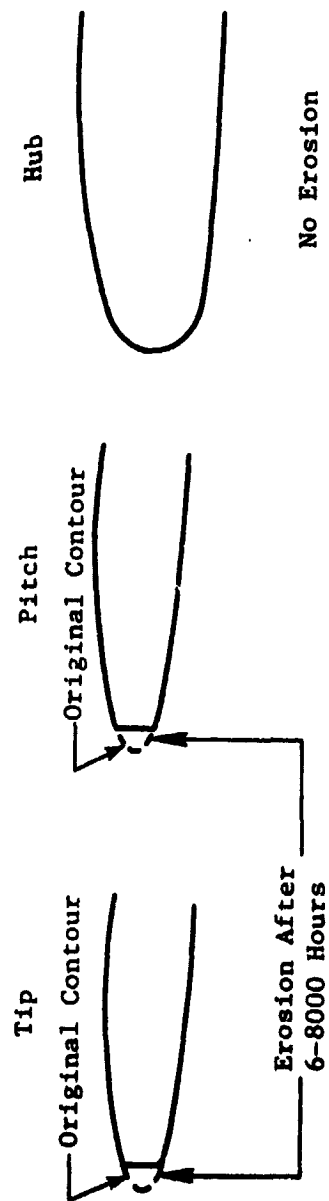
Figure 4-42. Erosion Pattern on Stage 1 Fan Blade.

The shape of the fan blade leading edge is extremely important for optimum performance. Erosion of the leading edge in 6,000 to 8,000 hours of engine operation has been observed to be a significant deterioration mode (Figure 4-42). While it is difficult to analytically assess the performance effects

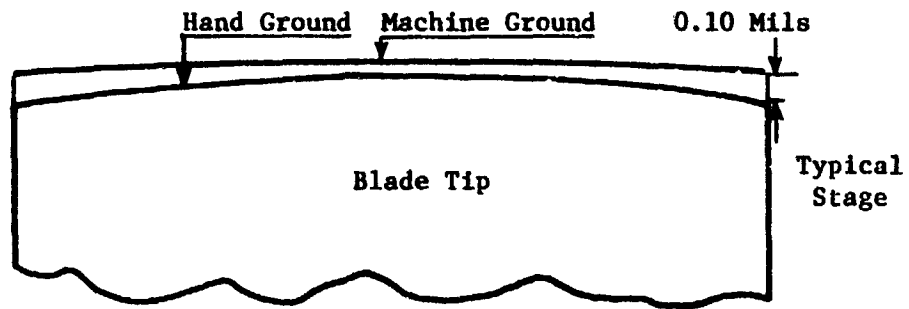
Figure 4-52. Types of Deterioration Modes: Casing Out of Roundness and Hand Grinding of Blade Tips.

Casing Out of Roundness Versus Stage

Hand Grinding of Blade Tips at Assembly

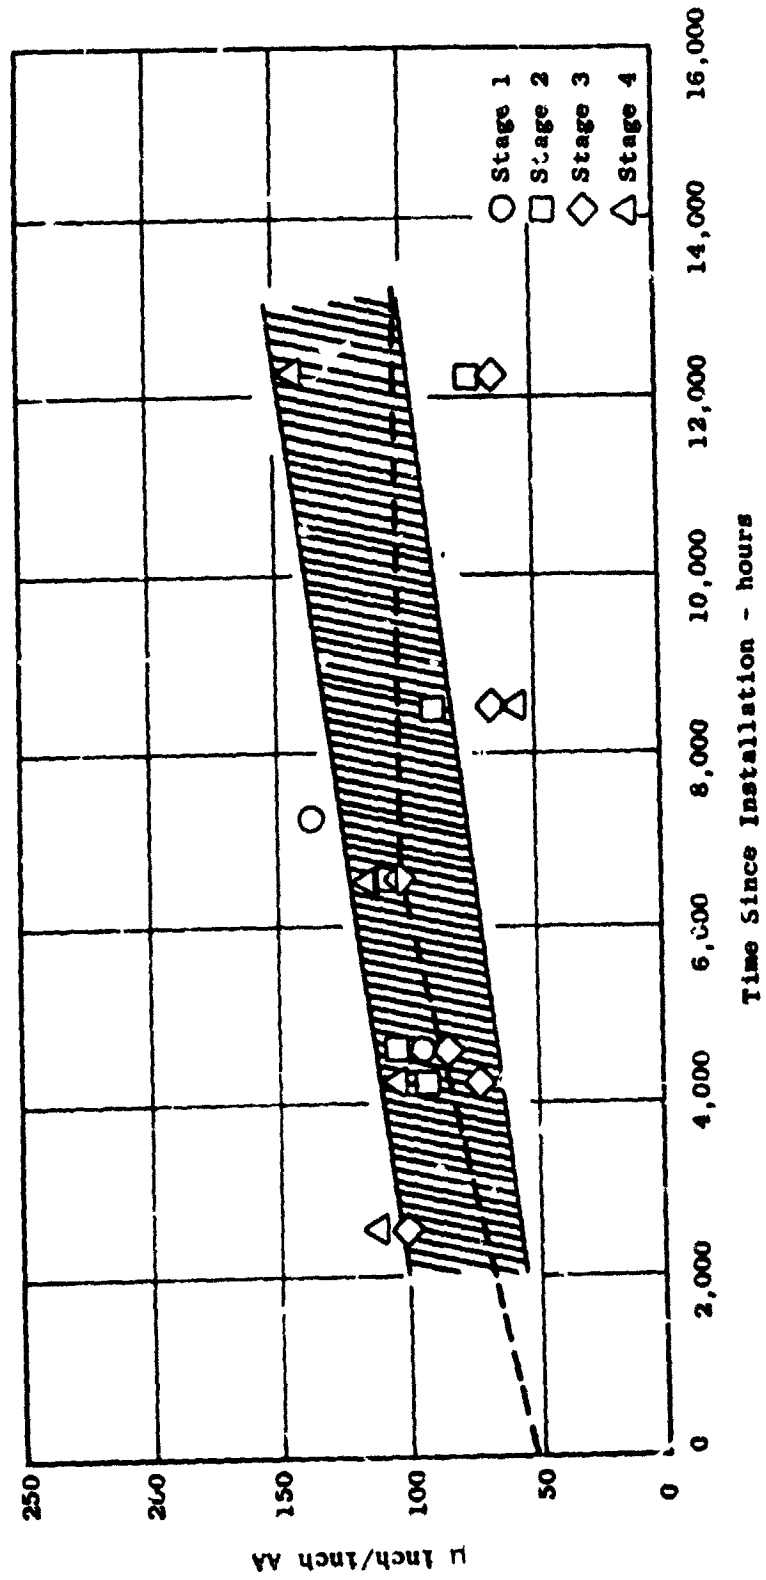
Figure 4-83. Degradation of IP Turbine Vane Surface Finish (Convex Side).

Deposits which degrade the surface finish were also noted for the higher temperature corrosion, but an additional and more lasting effect is also experienced. These deposits contain much larger amounts of sulfates which, while molten, remove the normal protective oxide scales formed on the surface of the metal thus destroying the metal's normal resistance to oxidation. The protective oxide scales do not reform as long as the sulfates' deposits remain on the surface. The loss of the protective oxide scales produces accelerated oxidation of the parent metal which also degrades the surface finish. These deposits can be removed using normal cleaning procedures, but the surface condition when there is parent metal attack is not restored by cleaning alone. The higher temperature corrosion is more likely to be experienced in the Stage 1 and 2 parts, since their metal temperatures are in the optimum range to produce this condition. However, experience to date indicates both types of conditions tend to overlap, and the distinction by stage in the LPT is less obvious. Most airfoil surfaces reviewed as part of this program have conformed to the lower rate of surface roughness increase as shown in Figures 4-83 and 4-84. Many of those have revealed corrosion in the sense of metallurgical attack, but this condition has not yet led to dramatic increases in surface roughness. In general, surface roughness effects are small, and the dashed lines shown in Figures 4-83 and 4-84 are the best estimates for average conditions. It also appears from these data that surface roughness continues to increase to 6,000 to 7,000 hours, and then remains relatively constant. Using the performance derivatives presented in Figures 4-85 and 4-86, average surface roughness changes of  $32\mu$  in./in. AA for the vanes and  $50\mu$  in./in. AA for the blades after 5,000 hours result in an approximate 0.07 percent decrease in LPT efficiency and a 0.03 percent increase in cruise SFC after 4,000 hours.
